Mid-Illinois Home Inspection

Property Address	1213 XXXXX Champaign, IL
Approximate Age	53 years
Approximate Square Footage	1730 sq. ft.
Number of Bedroom/Bath	3 bedroom/ 1 1/2 bath
Main Entrance Faces	North
Property Type	Residential
Garage	1 car/attached

Report Summary Page

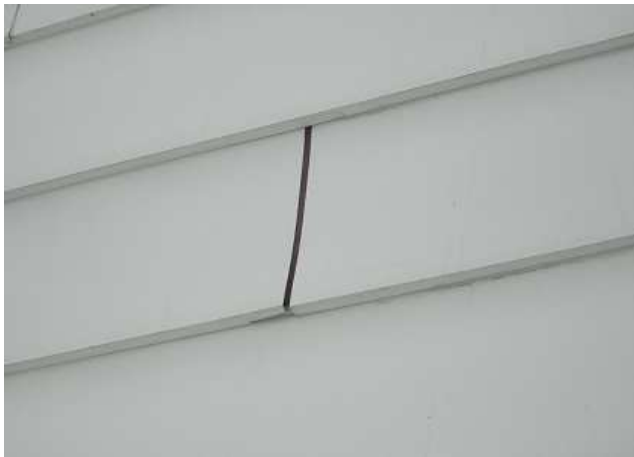
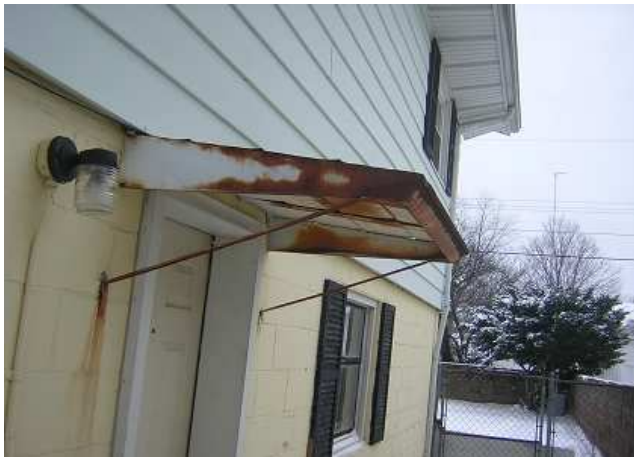
2.2.2 Exterior Wall & Trim Conditions **NR**

Comments: The vinyl siding has gaps between panels and other defects due to age and improper installation. The brick facade is separating at the corner of the garage and requires repair. The block portions need scraping and painting. An exterior awning is deteriorated.

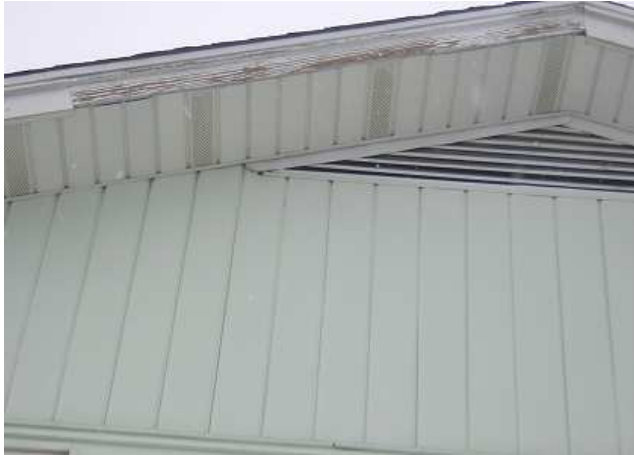
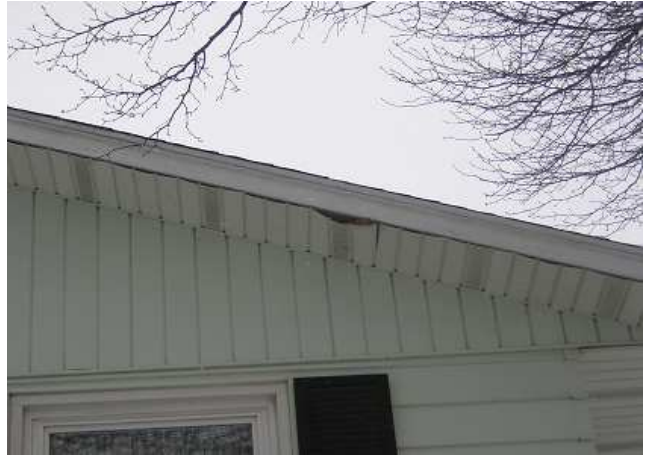
2.2.3 Eave/Soffit/Fascia Conditions **NR**

Comments: Soffit and fascia have missing pieces and need repair in several areas.

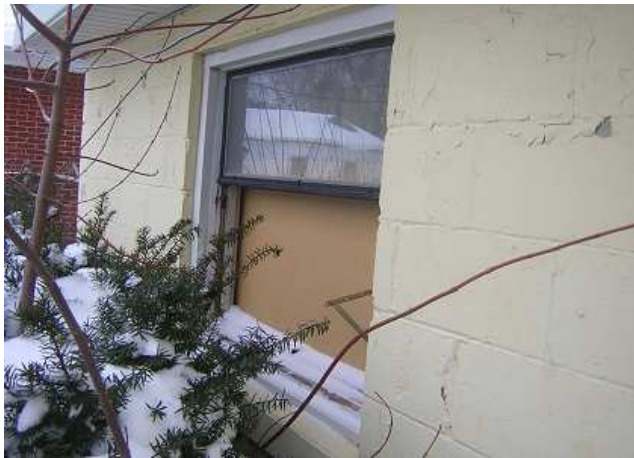
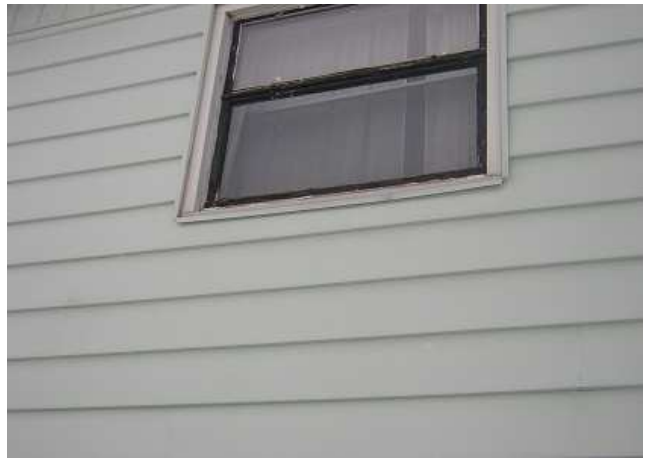
2.3.2 Window Frame Conditions

Comments: The older wood frame windows need replacement and are mostly non functional.

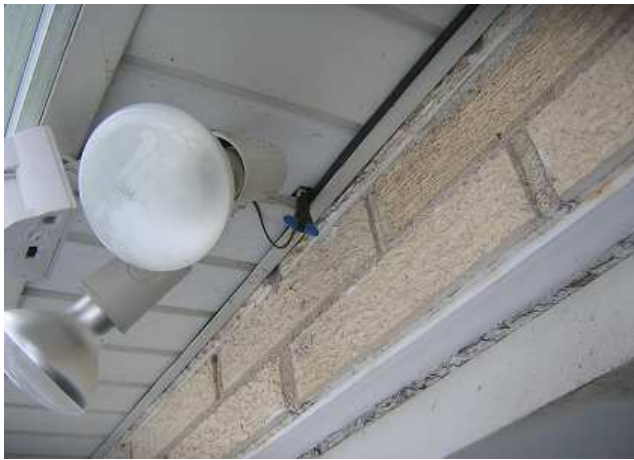
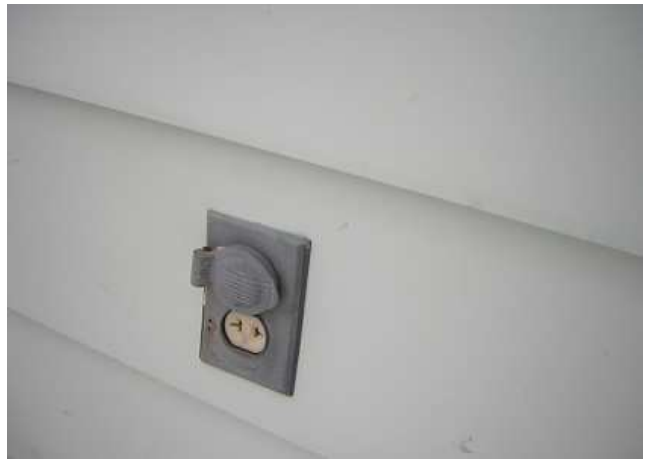
- 2.6.1 Electric Service** SWC Comments: The older electrical service will require replacement when electrical upgrades are done.
-
- 2.6.2 Exterior Outlets** NR Comments: Exterior outlets are not functioning and they need to be replaced with exterior ground fault outlets for safety.
-
- 2.6.3 Exterior Lighting and Wiring** NR Comments: Some exterior wiring looks to be installed improperly, including an exposed junction above the garage. There is also a low hanging phone cable in the backyard.

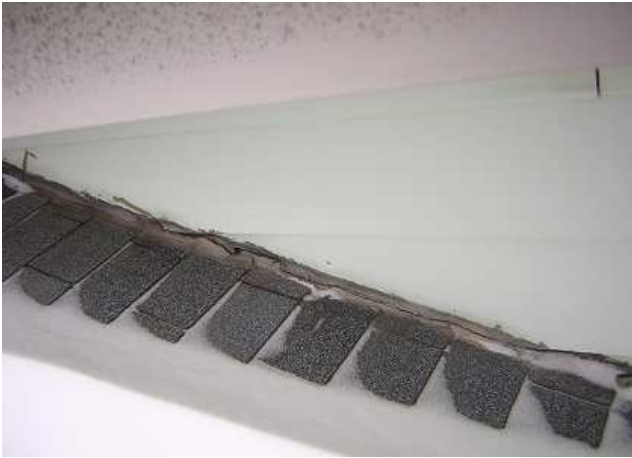
3.1.5 Roof Condition**SWC**

Comments: Worn roof shingles indicate the roof is near the end of its useful life. The wall-to-roof caulk seam is cracked and requires resealing.

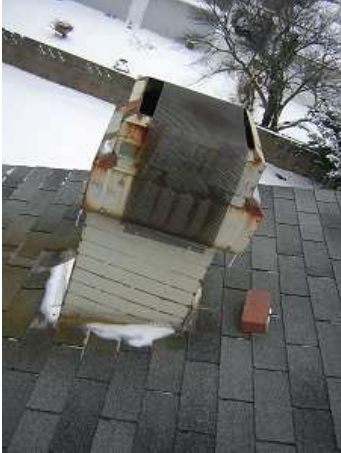
4.1.3 Chimney Condition**NR**

Comments: The chimney is rusted, needs caulking at its base, and is missing a cap to prevent water infiltration.

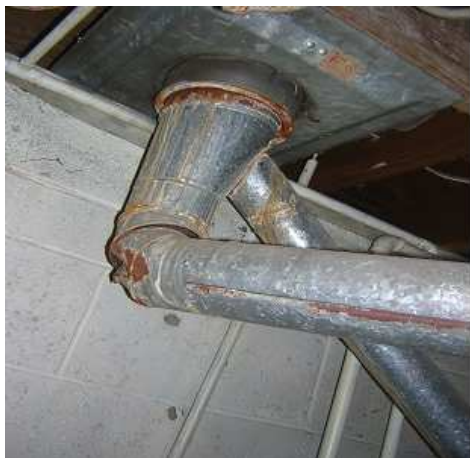
8.1.4 Unit Condition

Comments: The heating unit is operating, but needs a heating professional to provide service and additional evaluation. There is a scorched area at the access panel. The exhaust system needs repair and may allow exhaust fumes to enter the living area.

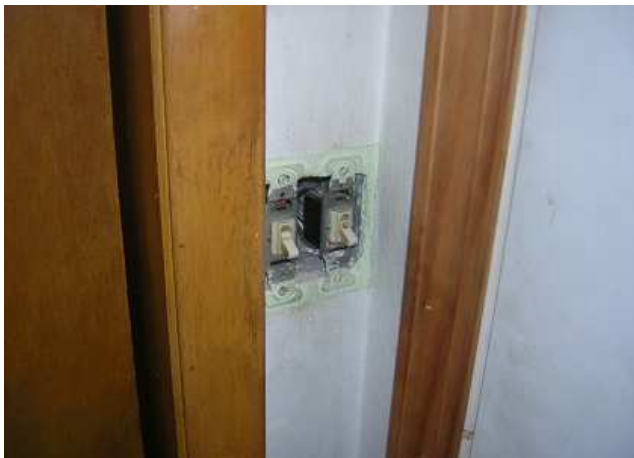
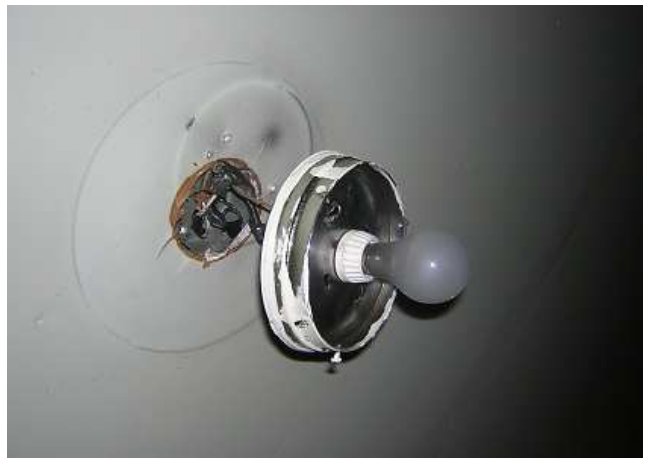
Comments: Exposed wiring, missing cover plates, and improper extension cords throughout the house need repair and correction. The dining room light dimmer switch is bad.

Comments: The lighting needs professional repair to correct defects.
